Bushfire Mitigation Plan 2022-2023

Documented Information			
Document Number	AU-3008-OPS-PHA-EL-PLN-00001	Version Number	2
Document Status	Draft	Hierarchy Level	3
Version Date	19/10/22	Next Review Date	25/5/23
Document Owner	Yuriy Odarenko	Controlled Document (Y or N)	Y
Document Approver	Cesar Salvatierra

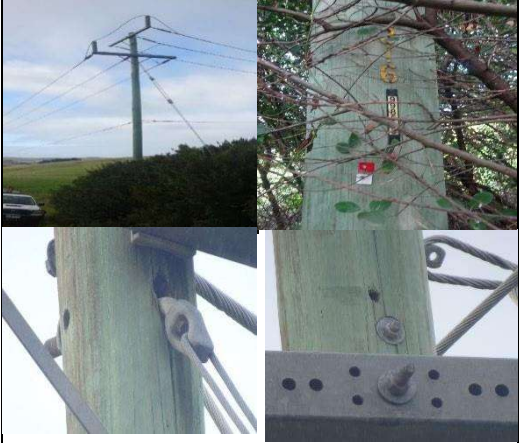
IS/Pole #: 998523 / 316 Reference: Ref 306-309	Observation	Priority

Hardware pulling through splits beyond 2m >>U/S not suit to stake<<	P2, Medium. Replacement of pole required

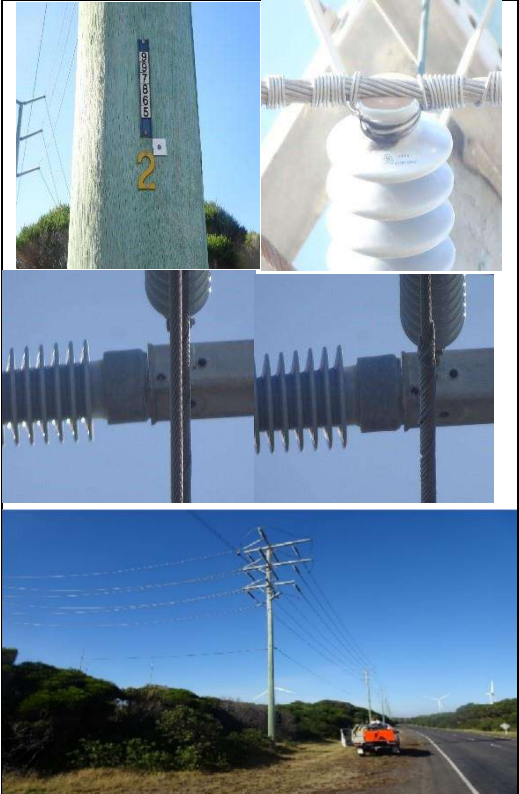
LIS/Pole #: 997865 / 2 Reference: Ref 1-5	Observation	Priority

P3 corroded tie pole insulator. Xarm 1+3 P2 loose nut West side	Low

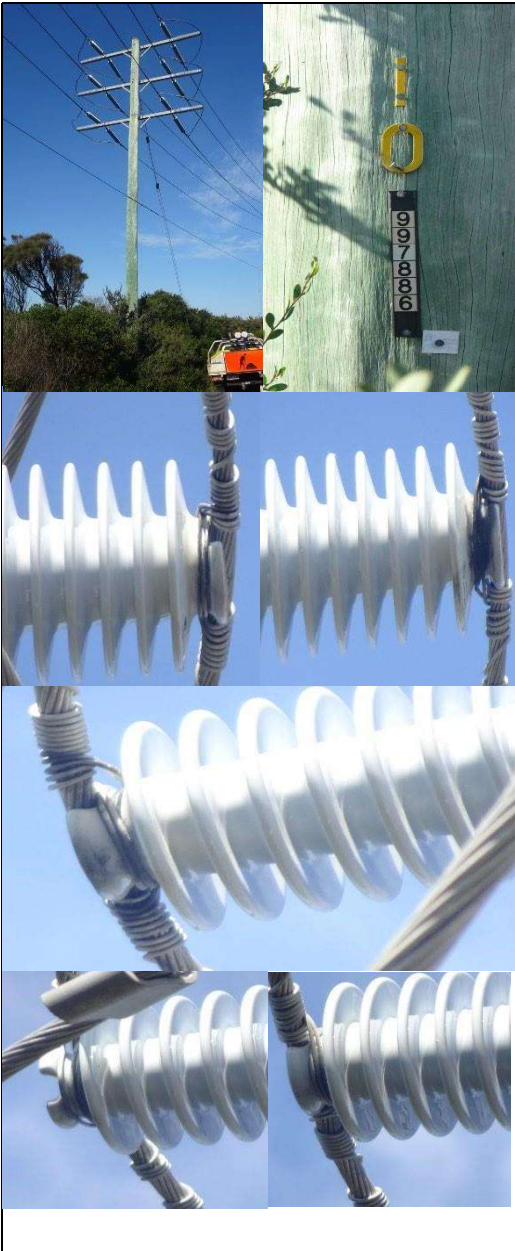
Minor split at top of pole. No issue yet. Incorrect installation	N/A
LIS/Pole #: 997886 / 10 Reference: Ref 15-21	Observation	Priority

<p>P3 corroded tie xarm 1 east + west xarm 2 east + west xarm 3 east</p>	<p>Low</p>
--	--	------------

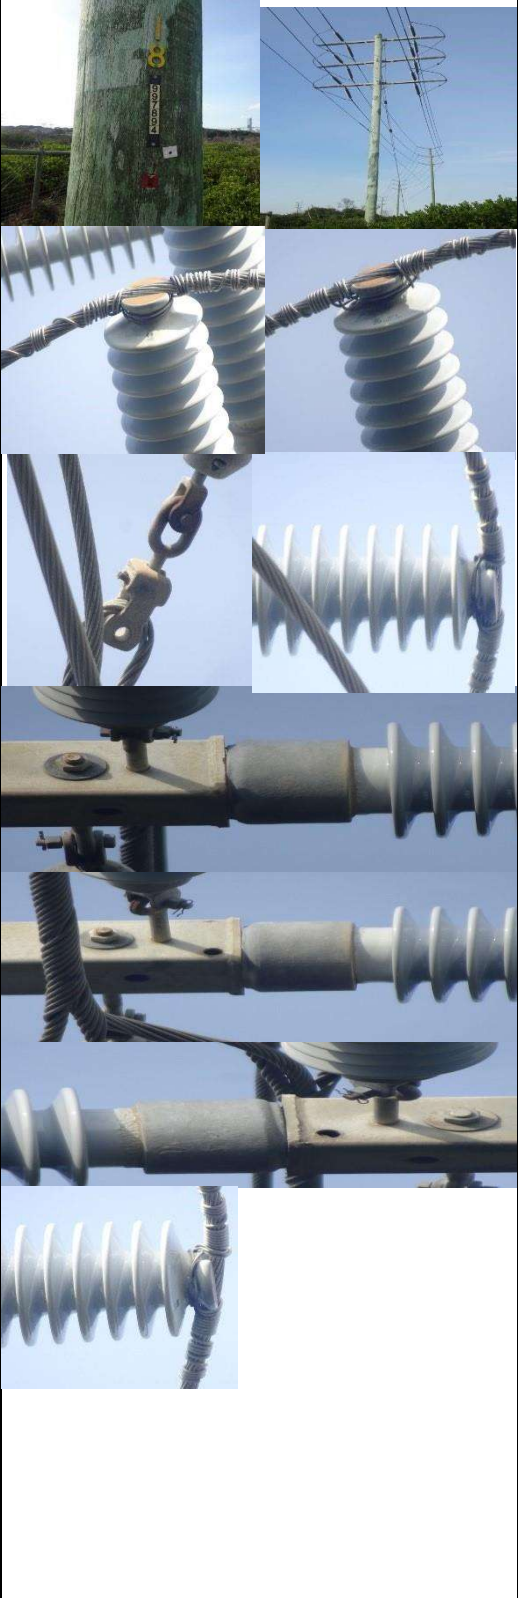
<p>P3 corroded tie xarm1 south + north xarm 2 south xarm3 south + north P2 partially secured W clip north east centre phase P2 loose nut xarm1 south xarm2 south + north</p>	<p>P3 Low P2 medium</p>
--	--	-----------------------------

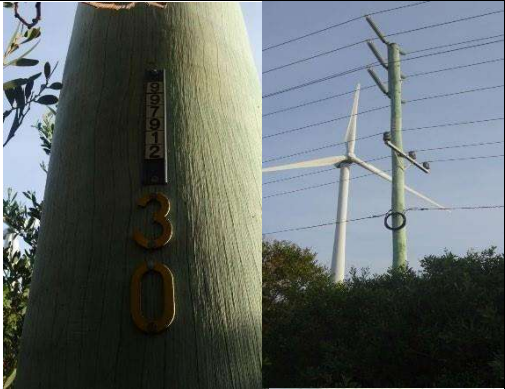
<p>LIS/Pole #: 997912 / 30 Reference: Ref 32-34</p>	<p>Observation</p>	<p>Priority</p>
---	--------------------	-----------------

<p>P3 loose insulator nut xarm 3 east side</p>	<p>Low</p>
--	--	------------

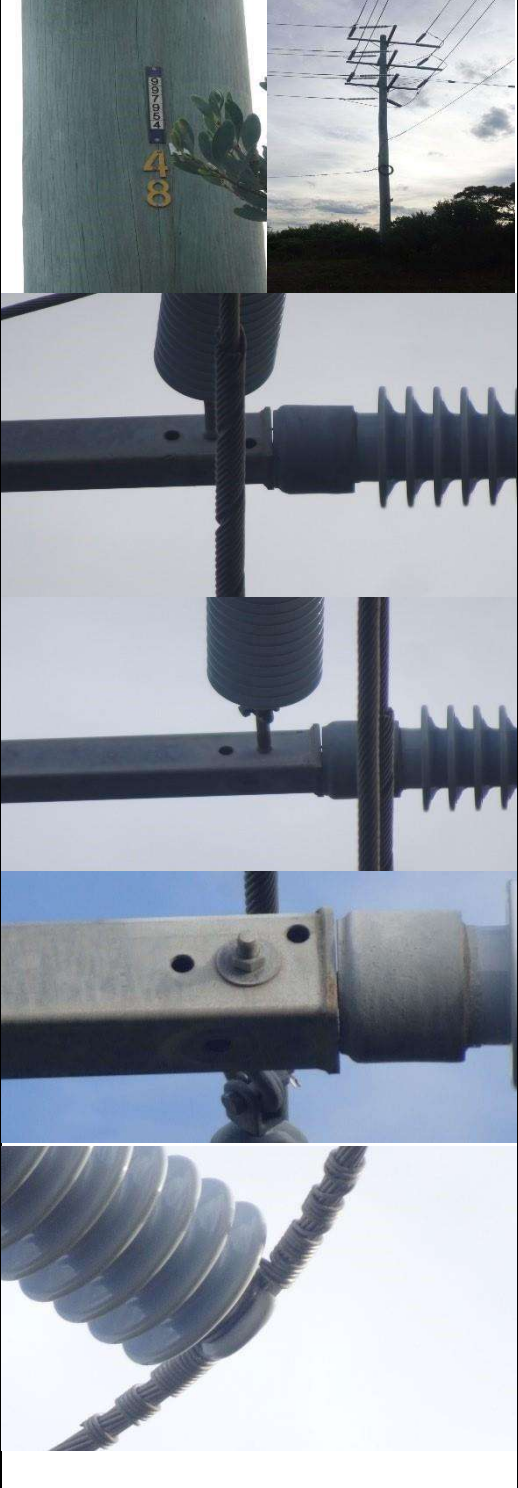
LIS/Pole #: 997954 / 48 Reference: Ref 43-48	Observation	Priority

<p>P3 corroded tie xarm2 north P2 loose insulator nut xarm1 east xarm3 east xarm4 north</p>	<p>P3 low P2 medium</p>
--	---	-----------------------------

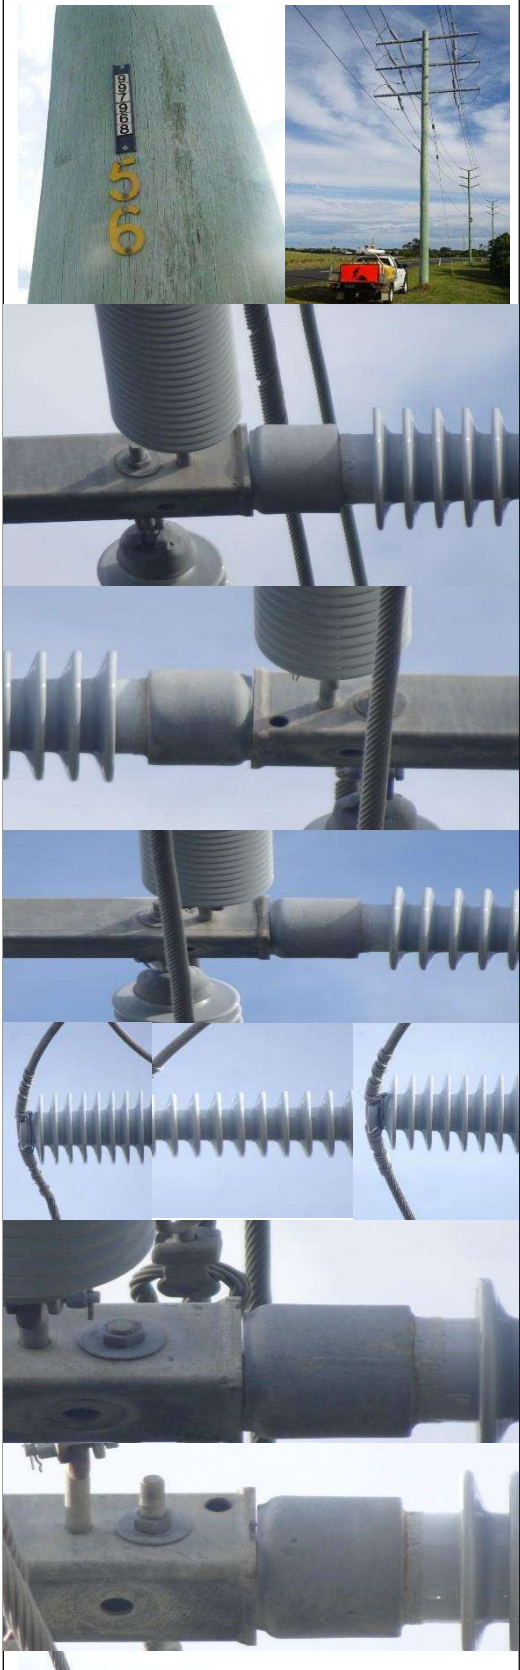
<p>LIS/Pole #: 997968 / 56 Reference: Ref 49 -59</p>	<p>Observation</p>	<p>Priority</p>
--	--------------------	-----------------

<p>P3 corroded tie xarm1 south xarm2 south xarm3 north + south P2 loose insulator nut xarm1 south xarm2 north xarm3 north + south</p>	<p>P3 low P2 medium</p>
<p>LIS/Pole #: 997990 / 64 Reference: Ref 60-64</p>	<p>Observation</p>	<p>Priority</p>

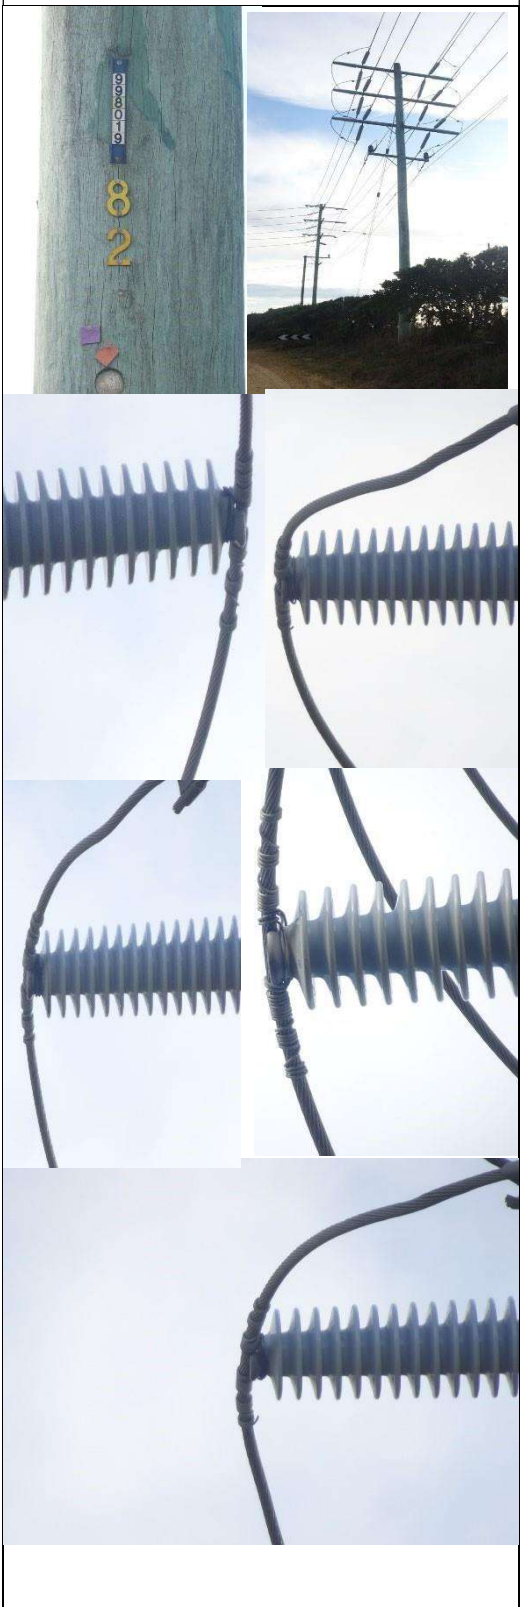
LIS/Pole #: 998919 / 82 Reference: Ref 77-83	Observation	Priority

<p>P3 corroded tie xarm1 south + north xarm2 south xarm3 south + north</p>	<p>Low</p>

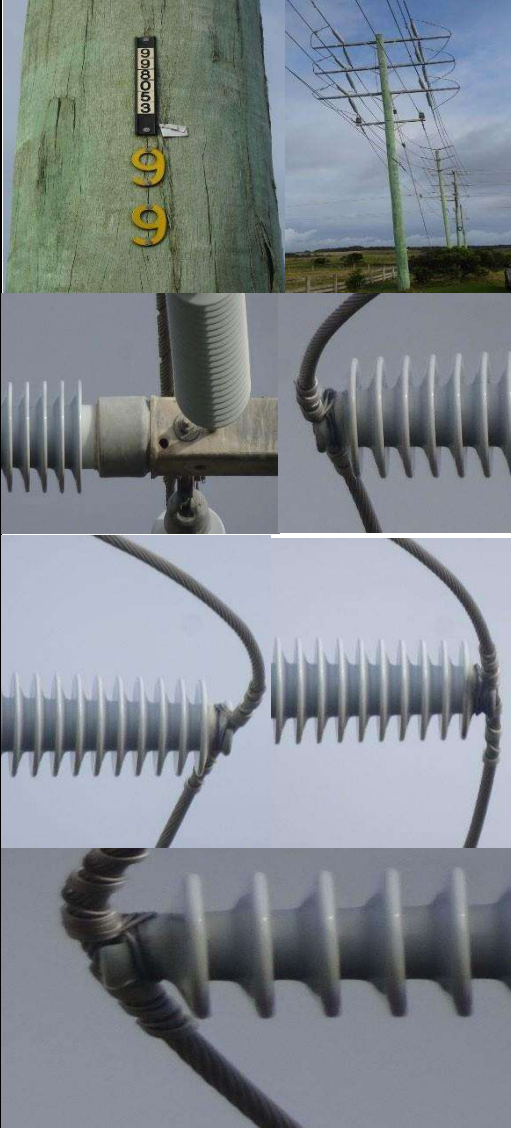
LIS/Pole #: 998053 / 99 Reference: Ref 94-100	Observation	Priority

<p>P3 corroded tie xarm1 north xarm2 north + south xarm3 south P2 loose insulator nut xarm3 south</p>	<p>P3 low P2 medium</p>

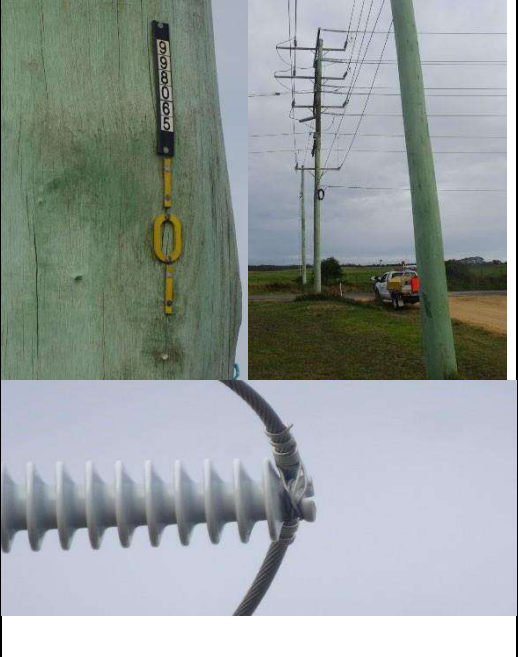
LIS/Pole #: 998065 / 101 Reference: Ref 101-103	Observation	Priority
--	-------------	----------

P3 corroded tie xarm3 west	Low
---	----------------------------	-----

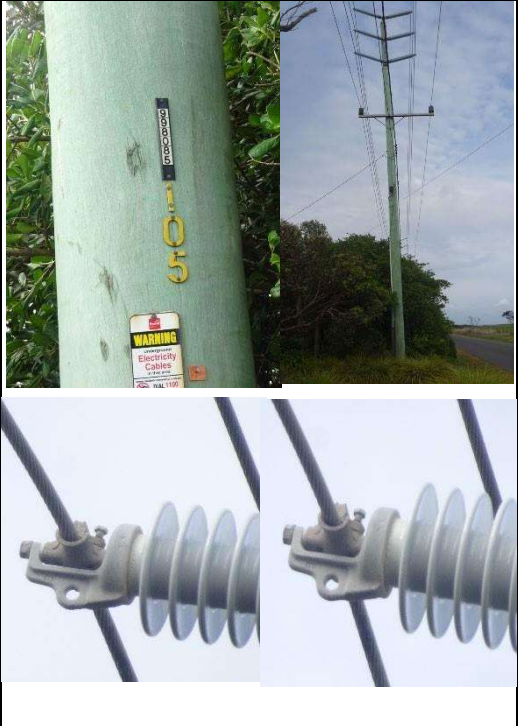
LIS/Pole #: 998085 / 105 Reference: Ref 104-107	Observation	Priority

P3 loose Clamp bolt xarm2 east xarm3 east	P3

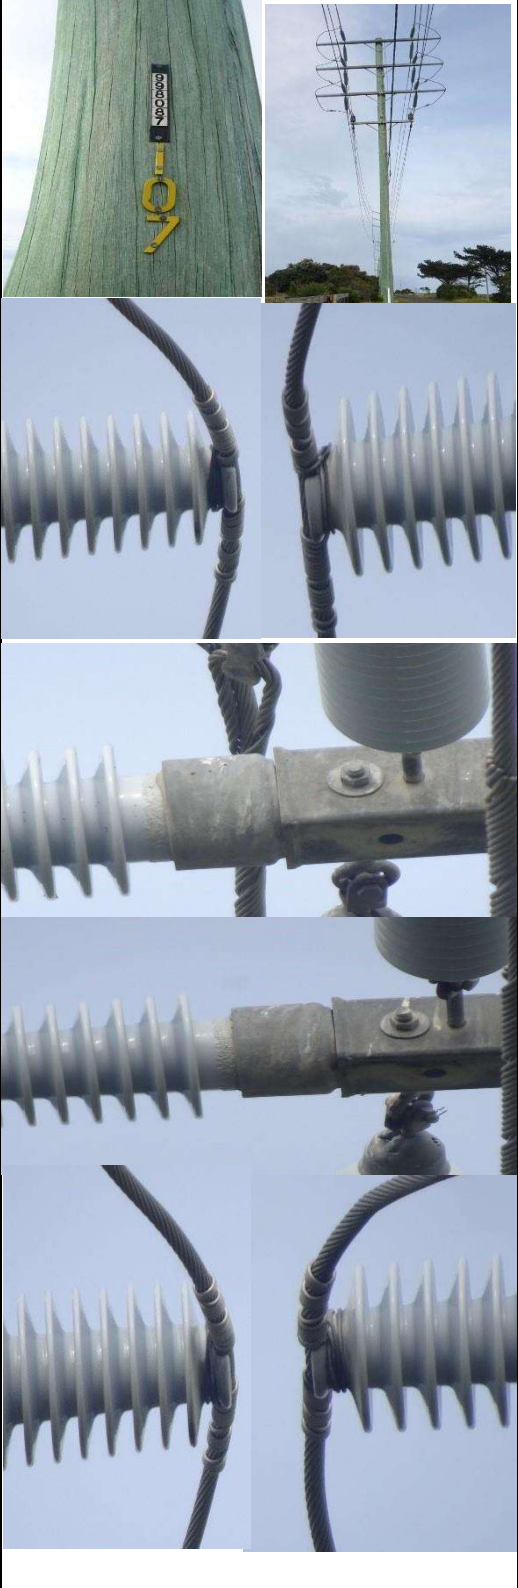
LIS/Pole #: 998087 / 107 Reference: Ref 108-115	Observation	Priority
--	-------------	----------

<p>P3 corroded tie xarm1 west xarm2 east xarm3 east + west P2 loose insulator nut xarm1 east xarm2 east</p>	<p>P3 low P2 medium</p>
--	---	-----------------------------

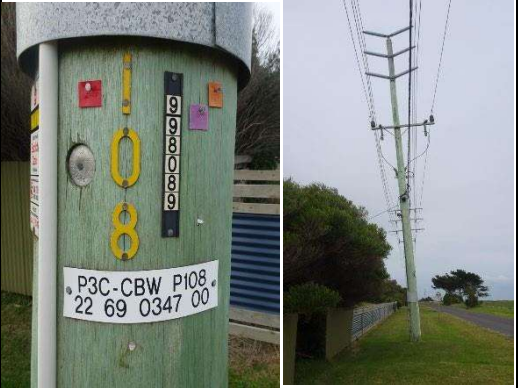
<p>LIS/Pole #: 998089 / 108 Reference: Ref 116-117</p>	<p>Observation</p>	<p>Priority</p>
--	--------------------	-----------------

P3 5 degree lean with pole mounted plant	Low
---	--	-----

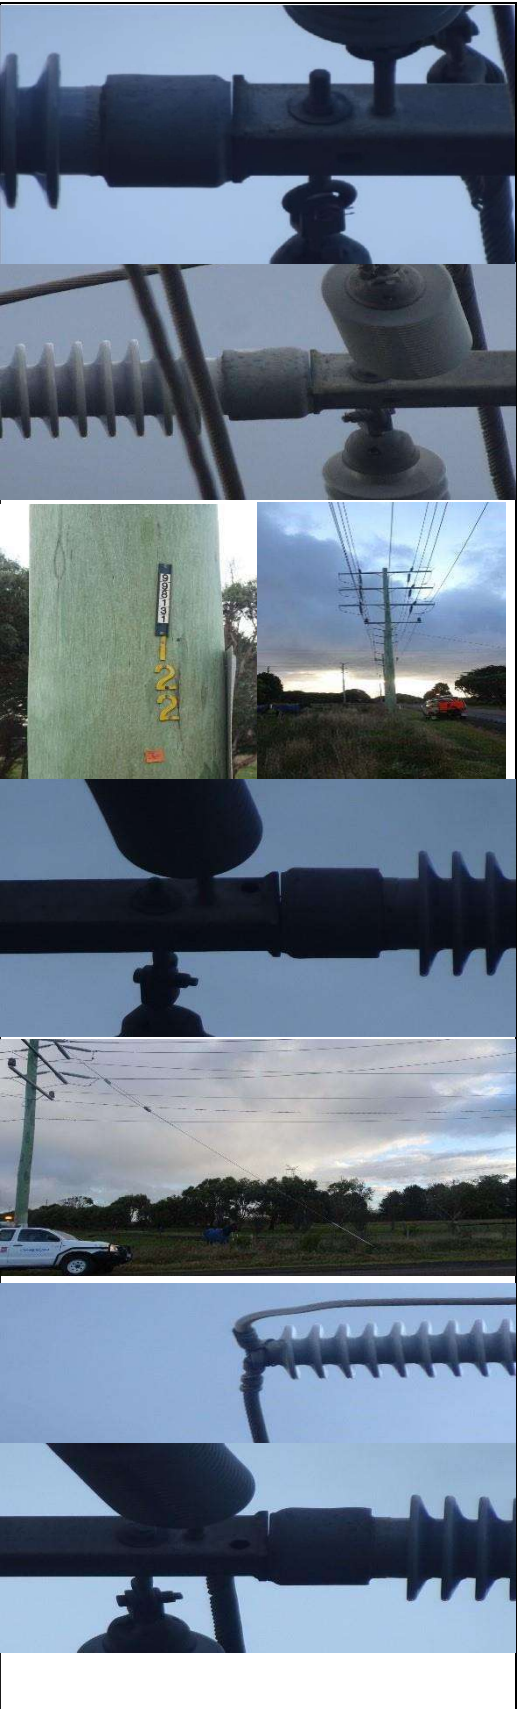
LIS/Pole #: 998131 / 122 Reference: Ref 120-127	Observation	Priority
--	-------------	----------

<p>P3 corroded tie xarm1 north P2 loose insulator nut xarm1 south xarm2 north + south xa north P2 loose stay cable</p>	<p>P3 low P2 medium</p>
--	--	-----------------------------

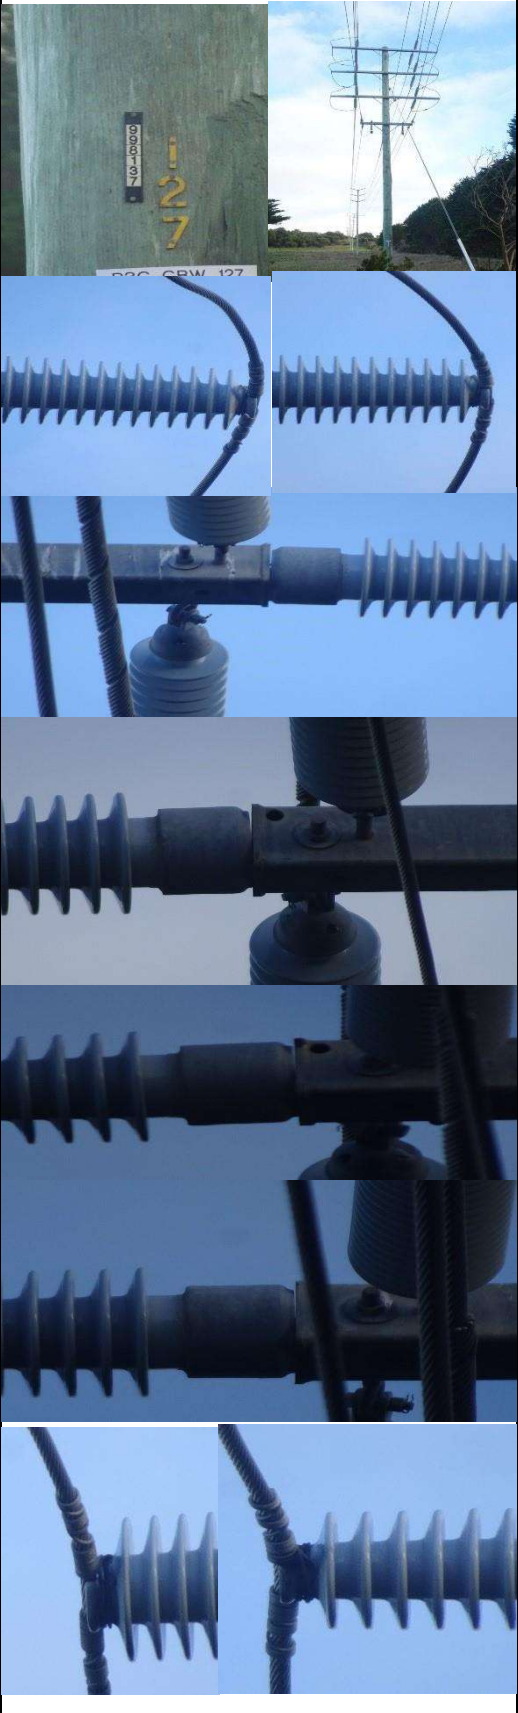
LIS/Pole #: 998137 / 127 Reference: Ref 128-137	Observation	Priority
--	-------------	----------

<p>P3 corroded tie xarm1 north + south xarm2 north + south P2 loose insulator nut xarm1 north + south xarm2 south xarm3 south</p>	<p>P3 low P2 medium</p>
--	---	-----------------------------

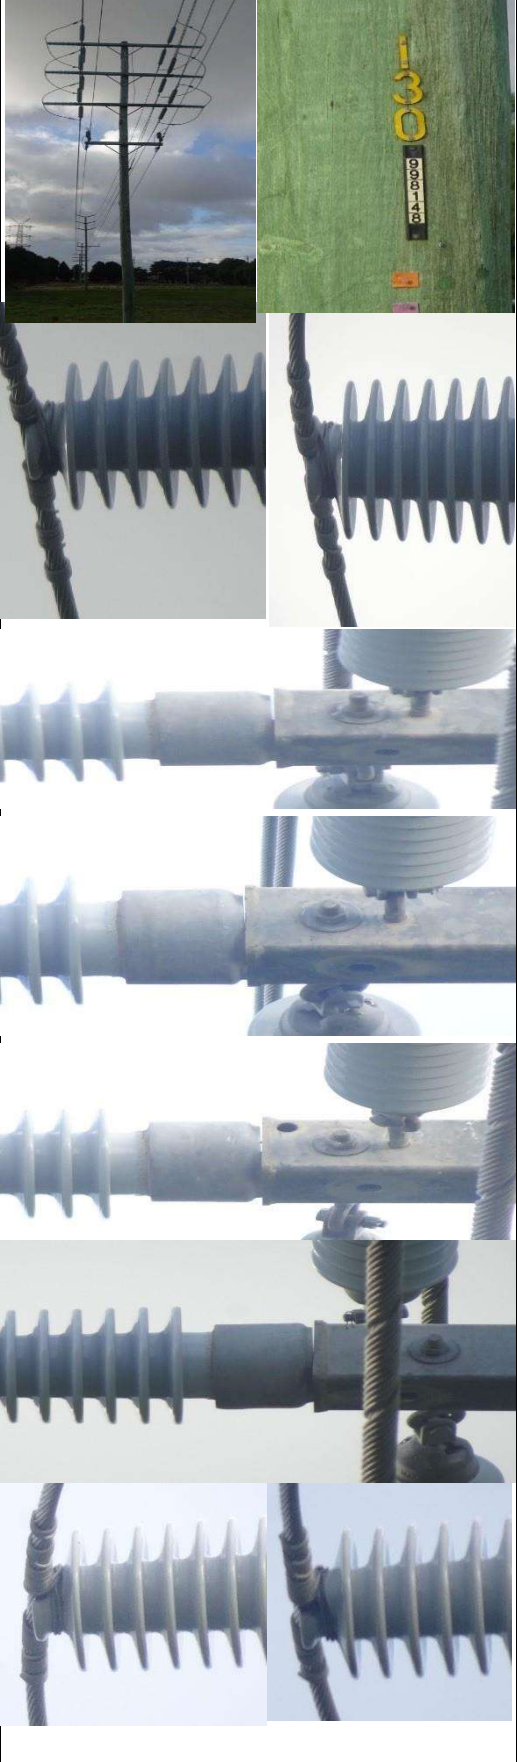
LIS/Pole #: 998148 / 130 Reference: Ref 138-147	Observation	Priority
--	-------------	----------

<p>P3 corroded tie xarm1 north + south xarm2 south xarm3 north P2 loose insulator nut xarm1 south xarm2 north + south xarm3 south</p>	<p>P3 low P2 medium</p>
--	---	-----------------------------

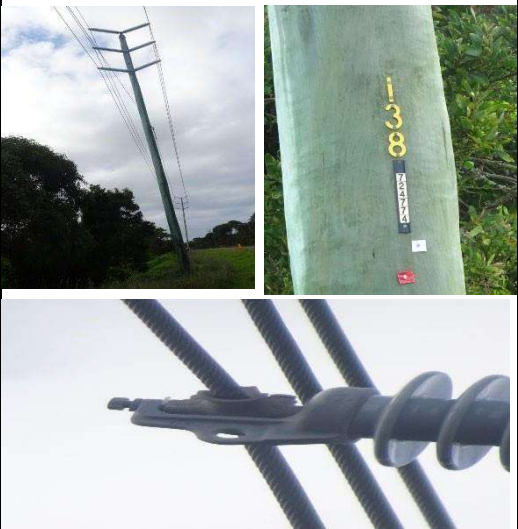
LIS/Pole #: 724774/ 138 Reference: Ref 148-150	Observation	Priority

<p>P3 loose insulator bolt xarm3 north P2 11degree lean >> elsewhere <<</p>	<p>P3 low P2 medium</p>
LIS/Pole #: 724797 / 147 Reference: Ref 151-155	Observation	Priority

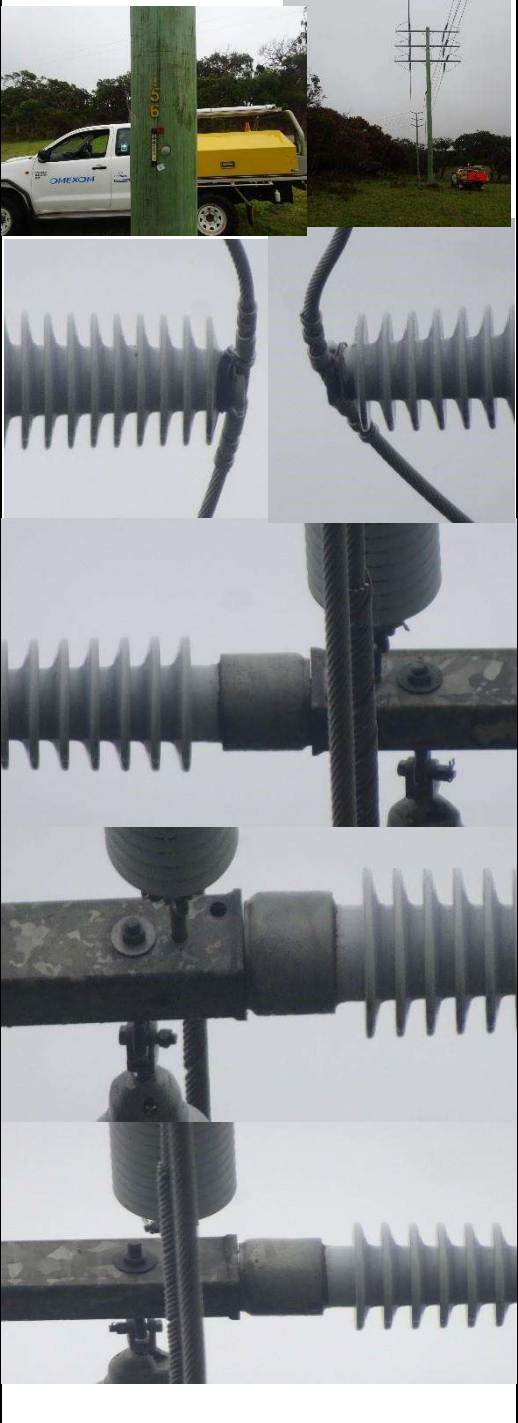
<p>LIS/Pole #: 998641 / 156 Reference: Ref 172-178</p>	<p>Observation</p>	<p>Priority</p>
--	--------------------	-----------------

<p>P3 corroded tie xarm1 north + south xarm2 north + south P2 loose insulator nut xarm1 south</p>	<p>P3 low P2 medium</p>
--	---	-----------------------------

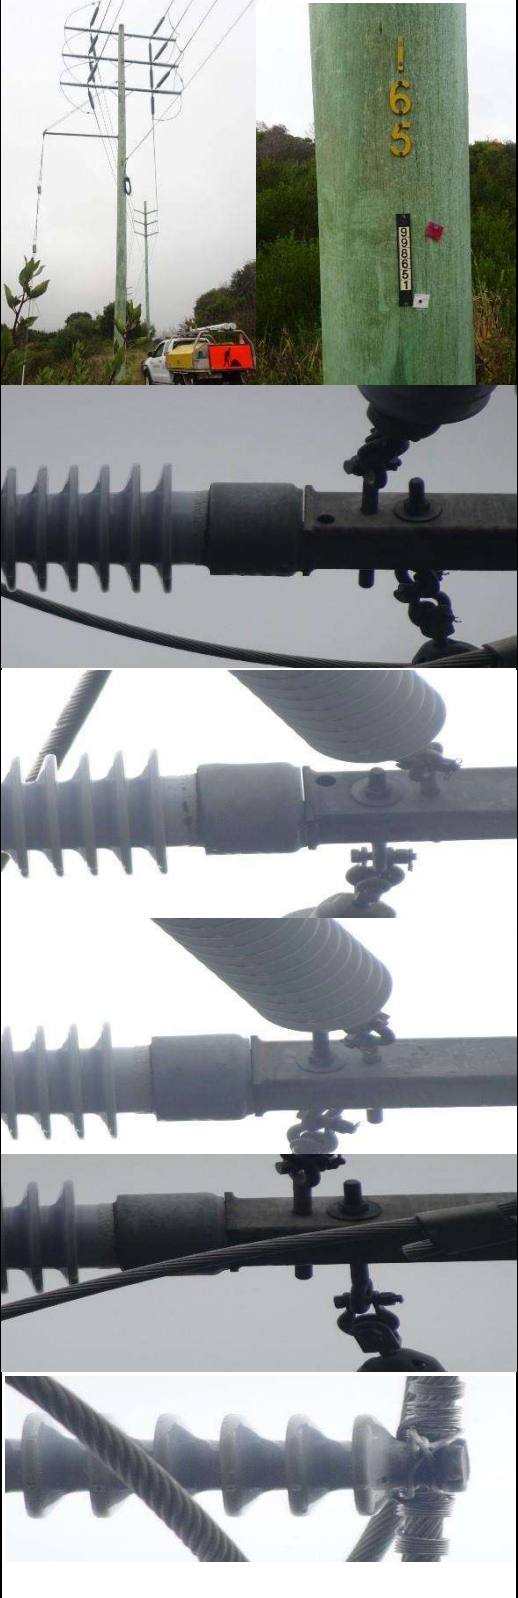
<p>LIS/Pole #: 998651 / 165 Reference: Ref 185-191</p>	<p>Observation</p>	<p>Priority</p>
--	--------------------	-----------------

<p>P3 corroded tie xarm2 north P2 loose insulator nut xarm1 south + north xarm2 north + south</p>	<p>P3 low P2 medium</p>
--	---	-----------------------------

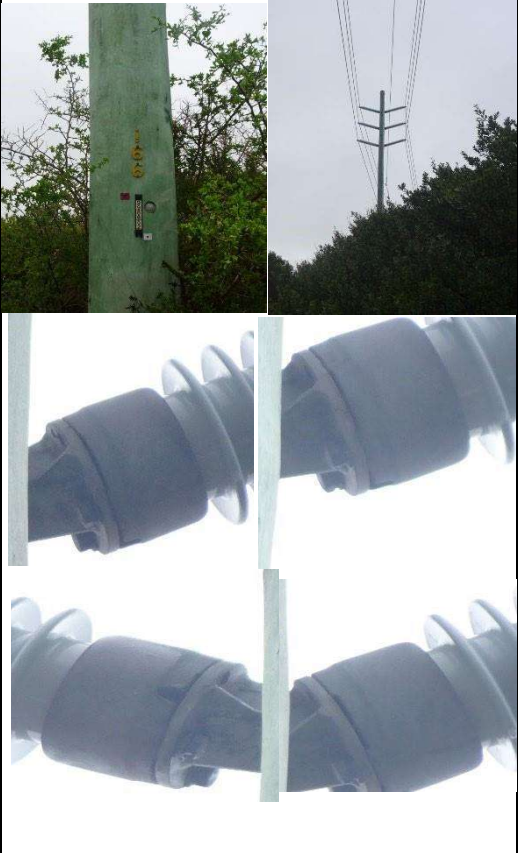
<p>LIS/Pole #: 998652 / 166 Reference: Ref 192-197</p>	<p>Observation</p>	<p>Priority</p>
--	--------------------	-----------------

<p>P2 missing insulator bolt xarm1 north + south xarm2 south xarm3 south</p>	<p>Medium</p>
--	--	---------------

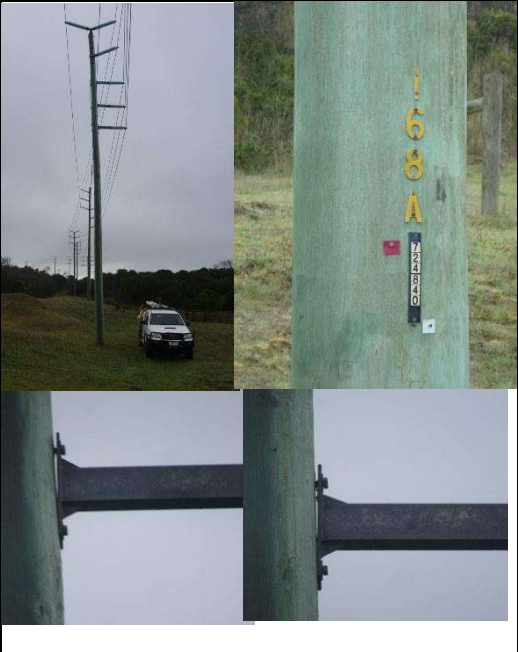
<p>LIS/Pole #: 724840 / 168A Reference: Ref 198-201</p>	<p>Observation</p>	<p>Priority</p>

<p>P3 loose kingbolt xarm3 + xarm4</p>	<p>Low</p>

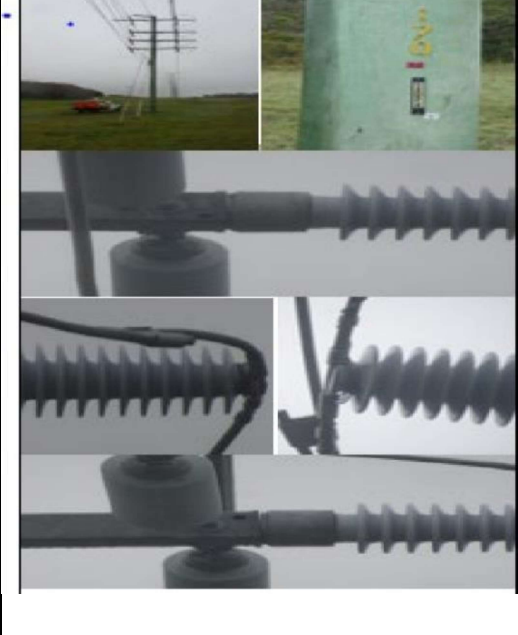
<p>LIS/Pole #: 998656 / 170 Reference: Ref 206-211</p>	<p>Observation</p>	<p>Priority</p>

<p>P3 corroded tie xarm3 north xarm4 north P2 loose insulator nut xarm1 north xarm4 north</p>	<p>P3 low P2 medium</p>

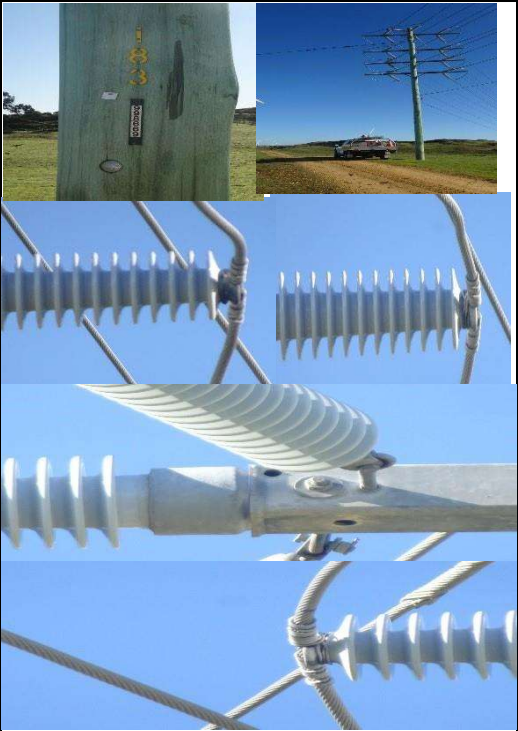
LIS/Pole #: 998669 / 183 Reference: Ref 212-217	Observation	Priority

P3 corroded tie xarm2 north xarm3 north xarm4 north P2 loose insulator nut xarm2 north	P3 low P2 medium
LIS/Pole #: 998687 / 184 Reference: Ref 218-220	Observation	Priority

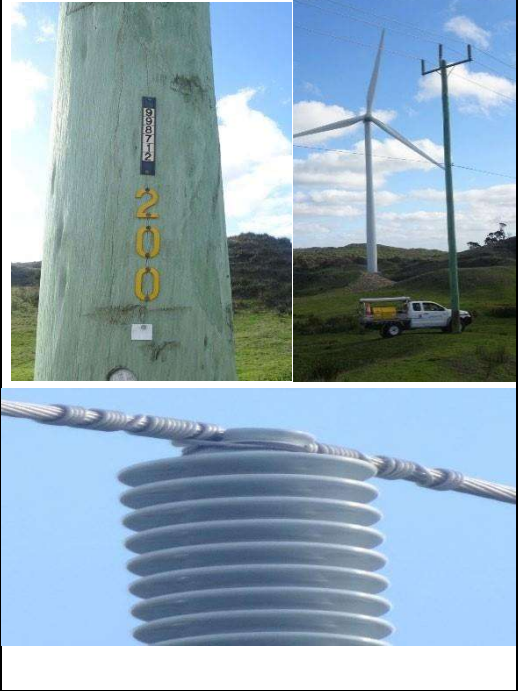
LIS/Pole #: 998712/ 200 Reference: Ref 231-233	Observation	Priority

P3 corroded tie xarm1 south	Low

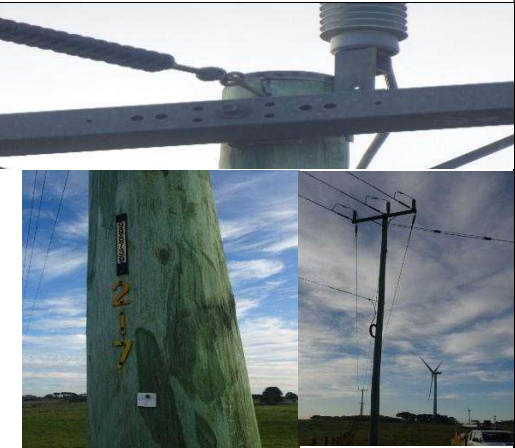
LIS/Pole #: 998739 / 217 Reference: Ref 241-243	Observation	Priority

Split at top of pole. No issue yet just for records. Incorrect installation	N/A

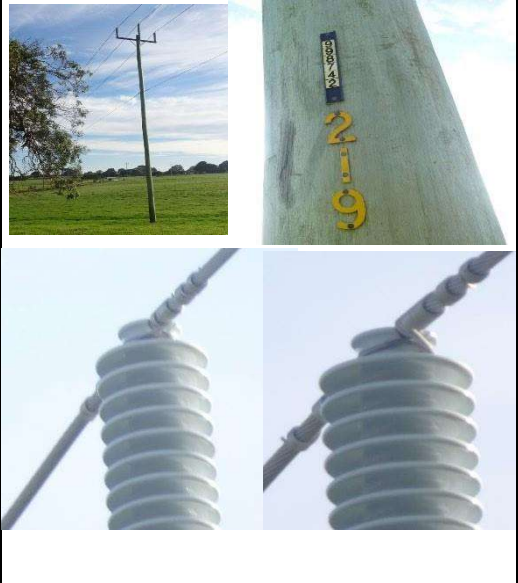
LIS/Pole #: 998742 / 219 Reference: Ref 244-247	Observation	Priority
--	-------------	----------

<p>P3 corroded tie xarm1 south + pole insulator</p>	<p>Low</p>
---	---	------------

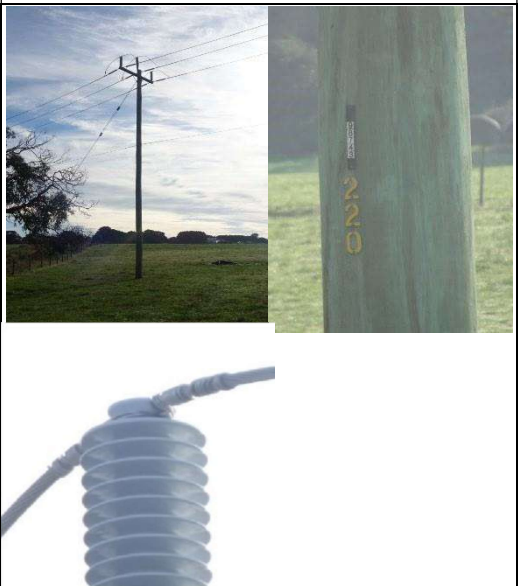
<p>LIS/Pole #: 998743 / 220 Reference: Ref 248-250</p>	<p>Observation</p>	<p>Priority</p>

<p>P3 corroded tie xarm1 north</p>	<p>Low</p>

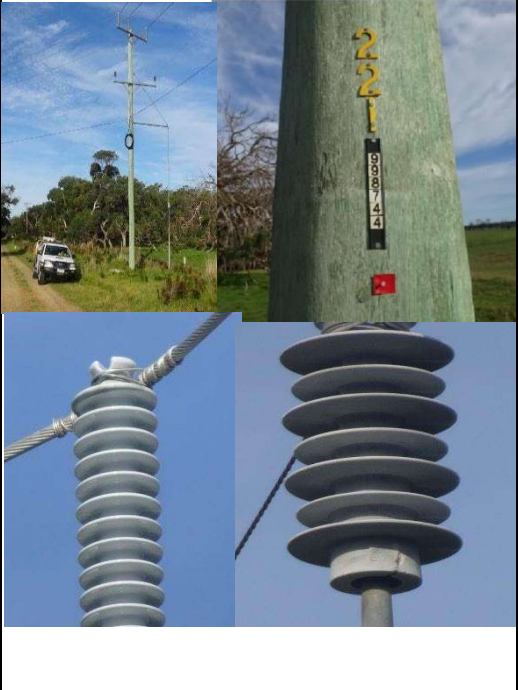
<p>LIS/Pole #: 998744/ 221 Reference: Ref 251-254</p>	<p>Observation</p>	<p>Priority</p>
---	--------------------	-----------------

P3 corroded tie	Low
---	-----------------	-----

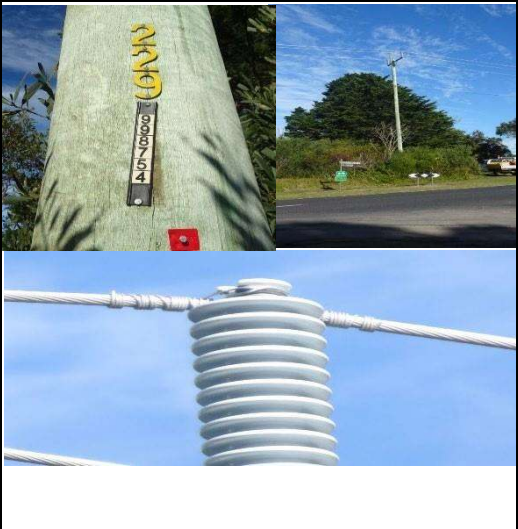
LIS/Pole #: 998754 / 229 Reference: Ref 255-257	Observation	Priority

P3 corroded tie xarm1 north	Low

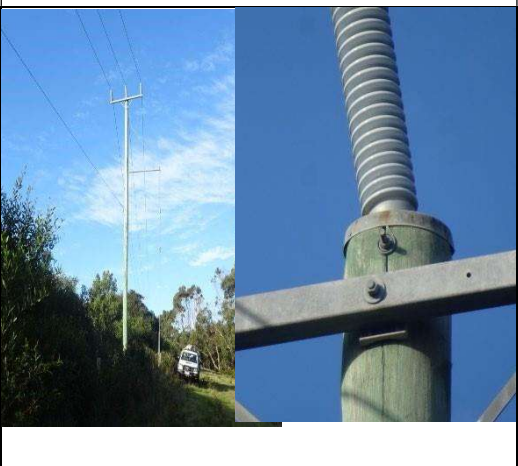
<p>LIS/Pole #: 998778 / 248 Reference: Ref 264-265</p>	<p>Observation</p>	<p>Priority</p>

<p>Split at top of pole due to incorrect installation - no defect just for records</p>

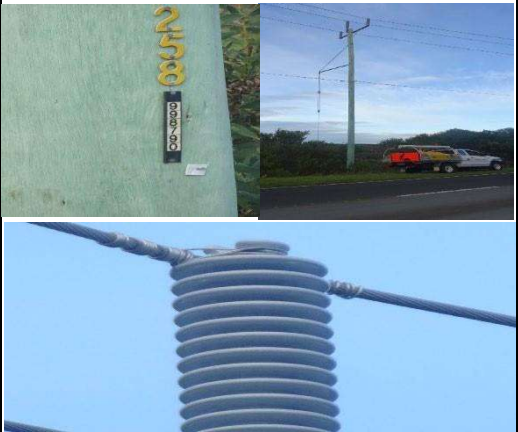
LIS/Pole #: 998790 / 258 Reference: Ref 267-269	Observation	Priority

P3 corroded tie xarm1 north	Low

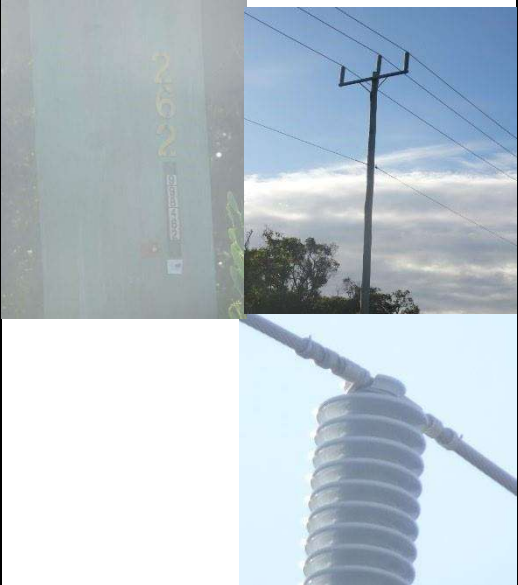
LIS/Pole #: 998462 / 262 Reference: Ref 270-272	Observation	Priority
--	-------------	----------

P3 corroded tie pole insulator	Low
---	--------------------------------	-----

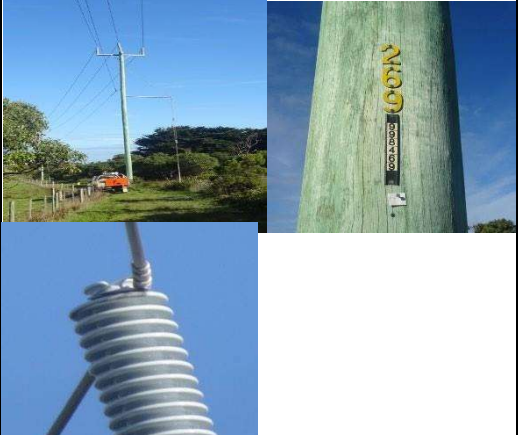
LIS/Pole #: 998469 / 269 Reference: Ref 273-275	Observation	Priority

P3 corroded tie pole insulator	Low

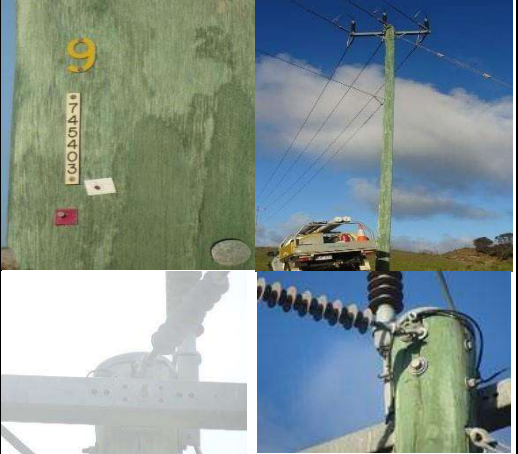
<p>Observation</p> <p>Split at top of pole due to incorrect installation - if it is to open up anymore pole will need to be replaced. I would suggest regular inspections</p>	<p>Priority</p> <p>N/A</p>

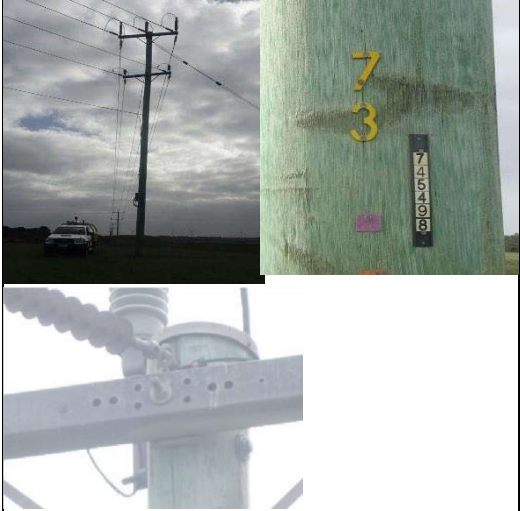
<p>Split at top of pole due to incorrect installation - no defect just for records</p>	<p>N/A</p>
---	--	------------
