Bushfire Mitigation Plan 2022-2023

Documented Information			
Document Number	AU-3008-OPS-PHA-EL-PLN-00001	Version Number	2
Document Status	Draft	Hierarchy Level	3
Version Date	19/10/22	Next Review Date	25/5/23
Document Owner	Yuriy Odarenko	Controlled Document (Y or N)	Y
Document Approver	Cesar Salvatierra

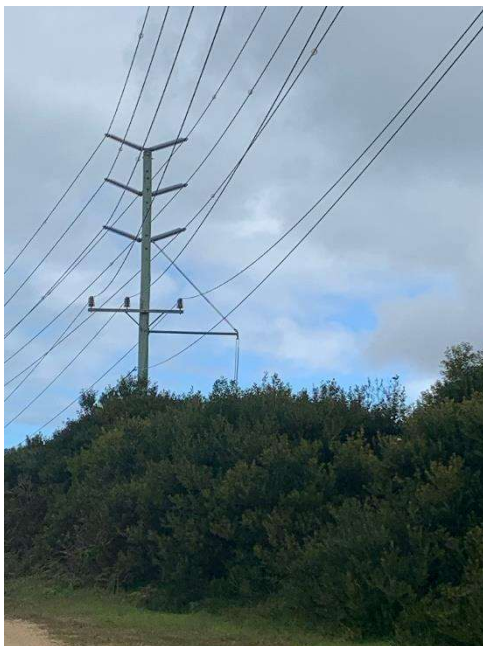
Location 1 Pole 38 Melaleuca

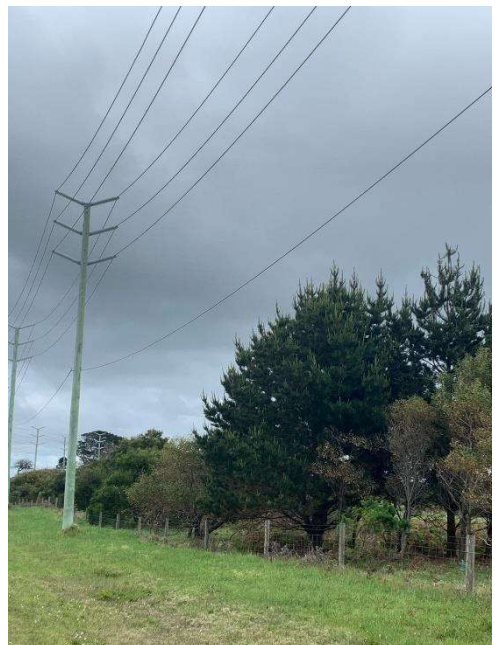
Location 2 Pole 54 Pine

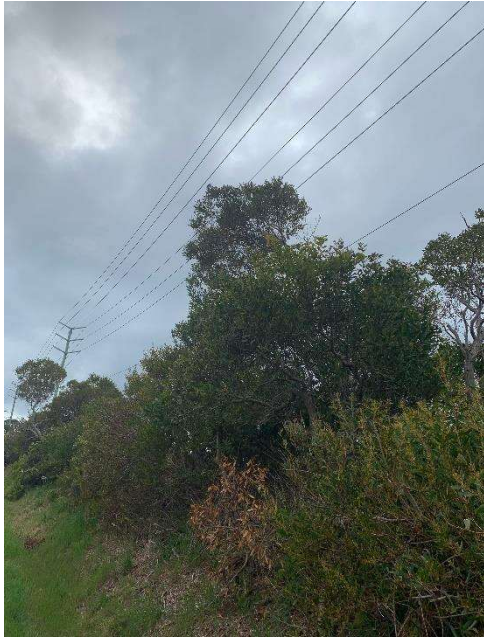
69/70

Location 3

Eucalyptus

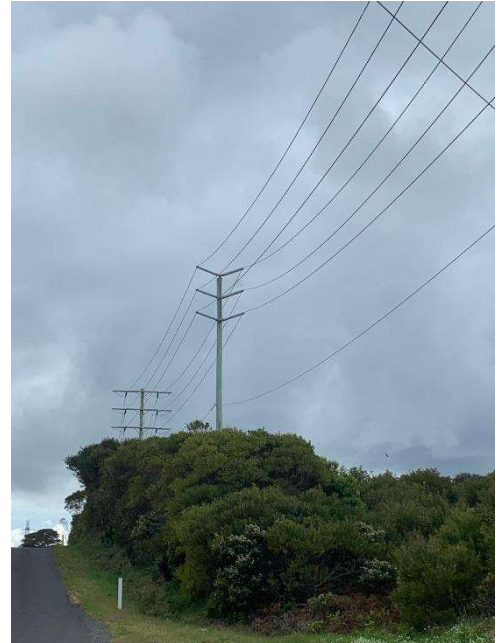
Melaleuca

Pole 67

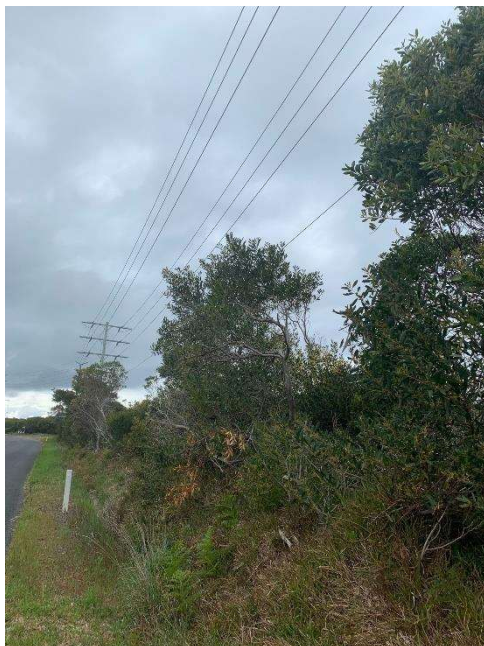
Location 5 Pole 73 Eucalyptus

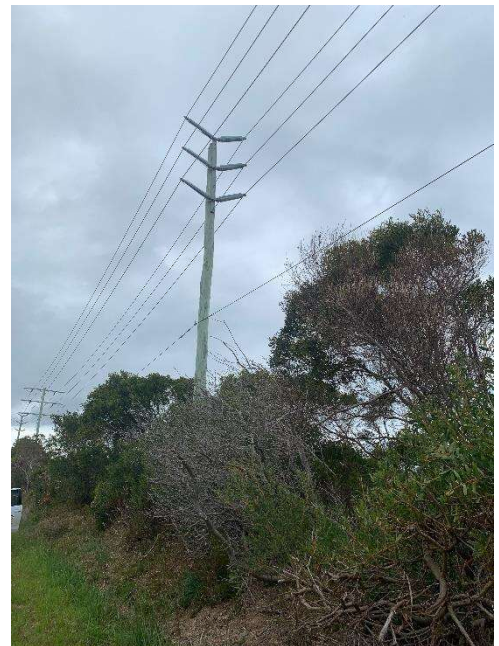
Location 6 Pole 78 Eucalyptus

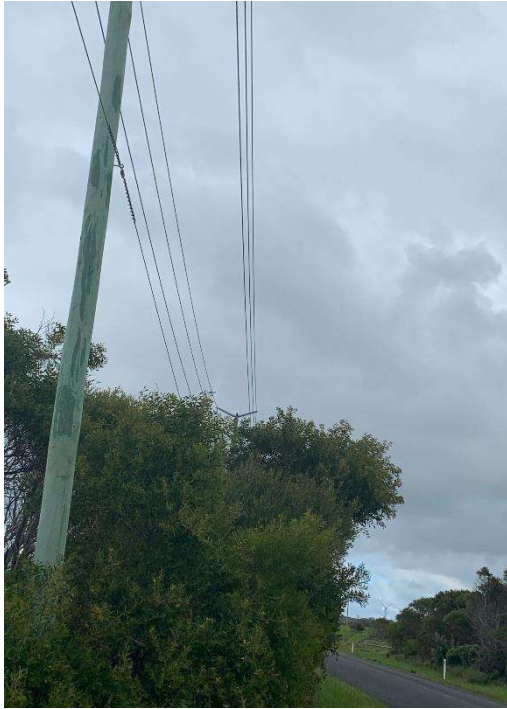
Location 7 Pole 289 A Eucalyptus

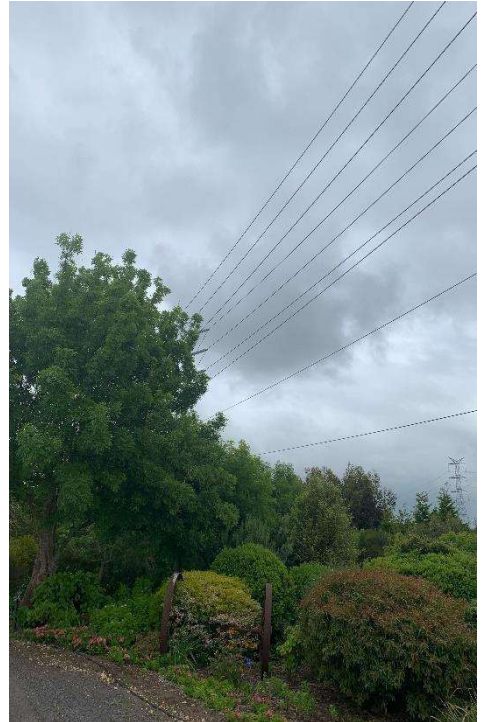
Location 8 Pole 132 Ash

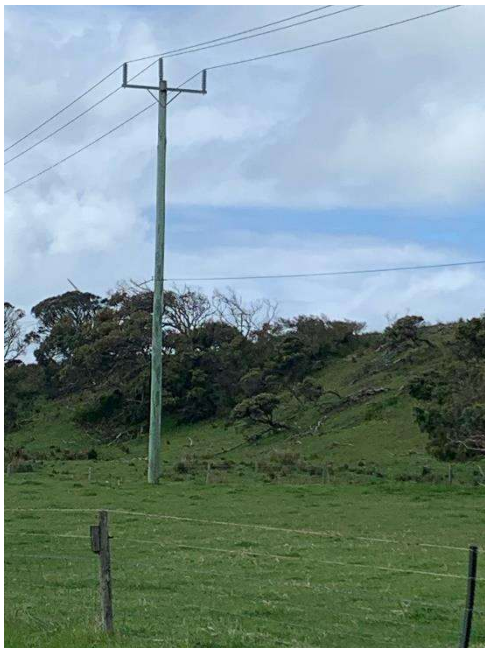
Location 9 Pole 205 Eucalyptus

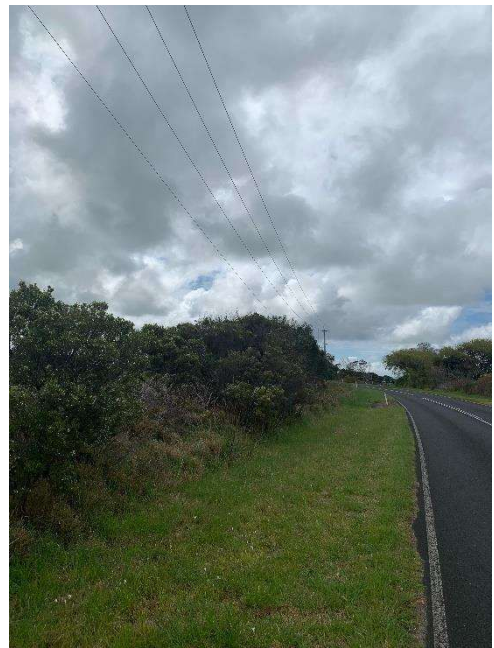
Location 10 Pole 235 Eucalyptus

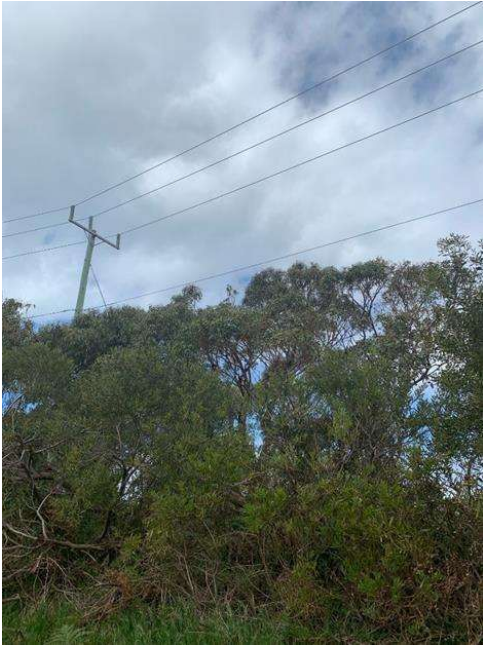
Location 11 Pole 290 Eucalyptus

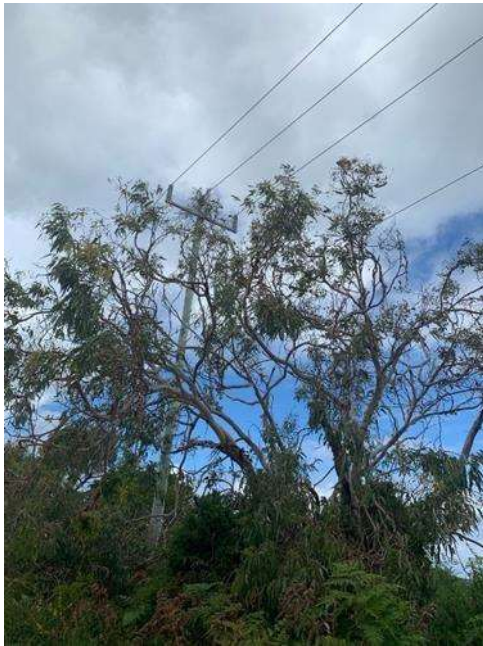
Location 13 Pole 290 Eucalyptus

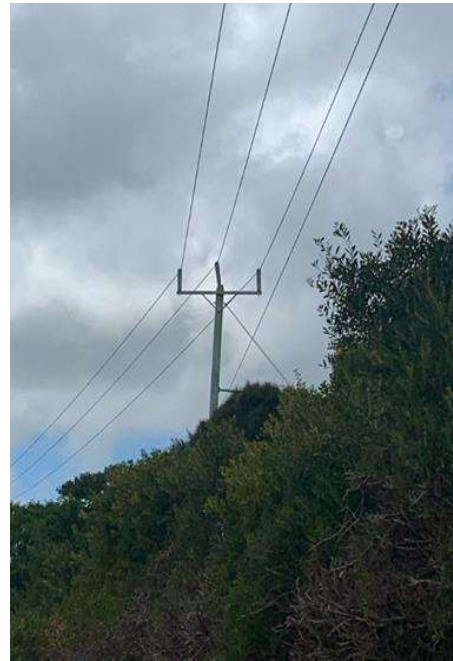
Location 14 Pole 299 She oak

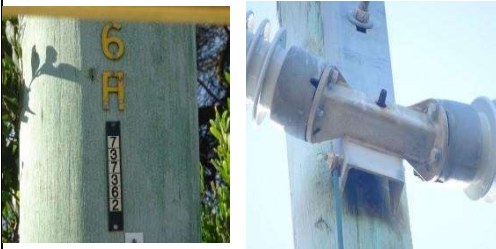
P2 missing kingbolt nut xarm 1 - corrosion	Medium
LIS/Pole #: 997883 / 7 Reference: Ref 13-14	Observation	Priority

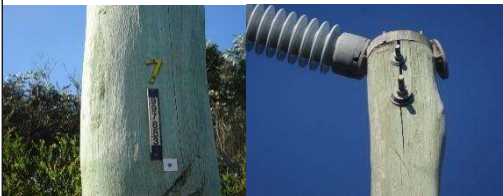
Minor split at top of pole. No issue yet. Incorrect installation	N/A
LIS/Pole #: 997886 / 10 Reference: Ref 15-21	Observation	Priority

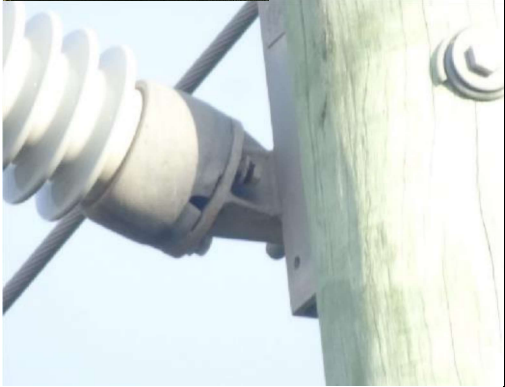
<p>P3 loose insulator nut xarm 3 east side</p>	<p>Low</p>
--	--	------------

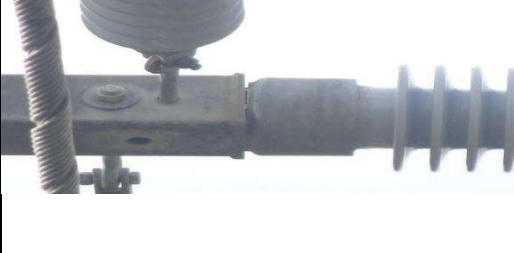
<p>P3 corroded tie xarm1 east xarm2 east P2 loose insulator nut xarm1 east</p>	<p>P3 low P2 medium</p>
--	--	-----------------------------

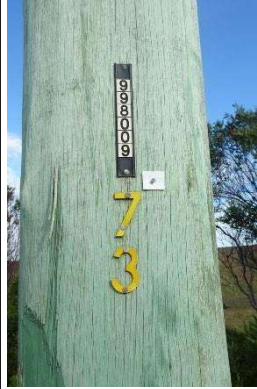
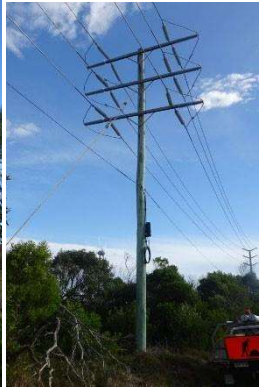
<p>P3 corroded tie xarm2 east + west xarm3 west side</p>	<p>Low</p>

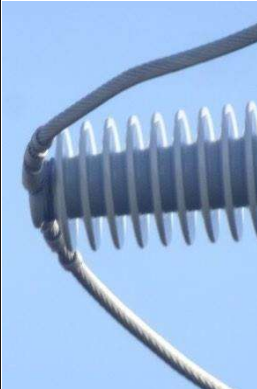
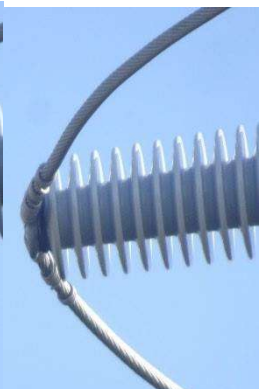
<p>P3 corroded tie xarm1 south xarm2 south xarm1 south p2 loose insulator nut xarm1 north xarm3 north</p>	<p>P3 low P2 medium</p>

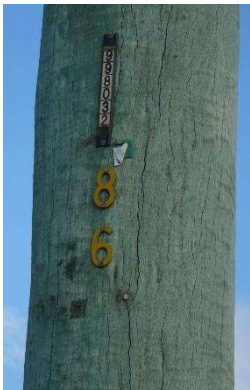
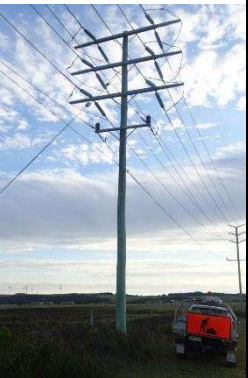
P3 corroded tie xarm3 south xarm1 north xarm2 north P2 loose insulator nut xarm1 south	P3 low P2 medium

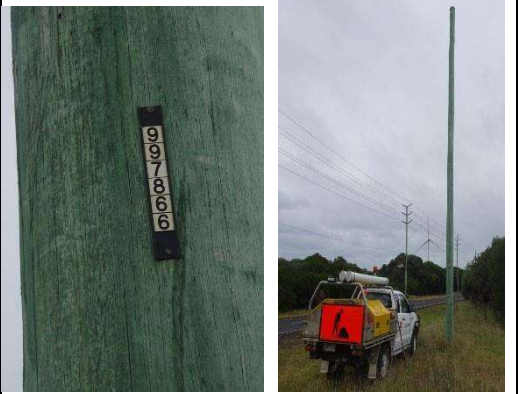
P3 unused asset	Low

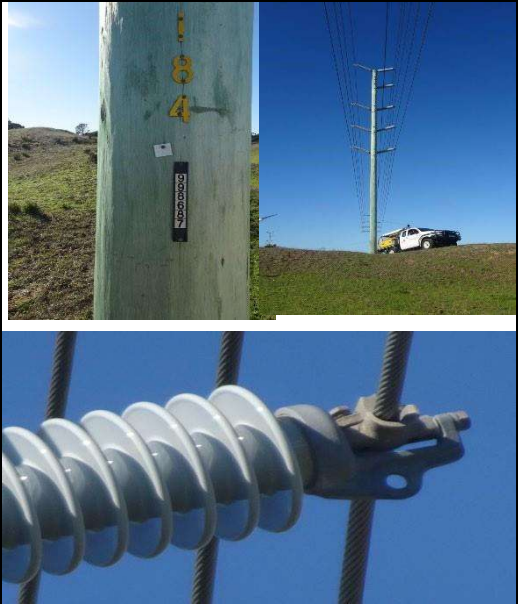
P3 corroded tie xarm2 north xarm3 north xarm4 north P2 loose insulator nut xarm2 north	P3 low P2 medium
LIS/Pole #: 998687 / 184 Reference: Ref 218-220	Observation	Priority

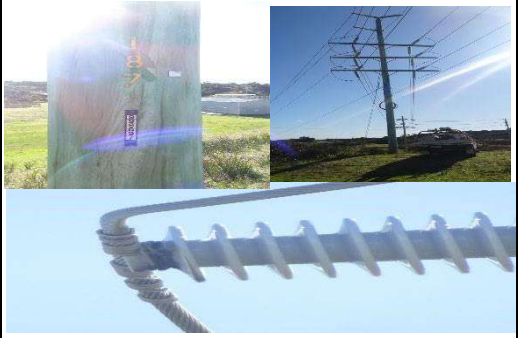
P3 loose clamp bolts xarm2 south	Low
LIS/Pole #: 998697 / 187 Reference: Ref 221-223	Observation	Priority

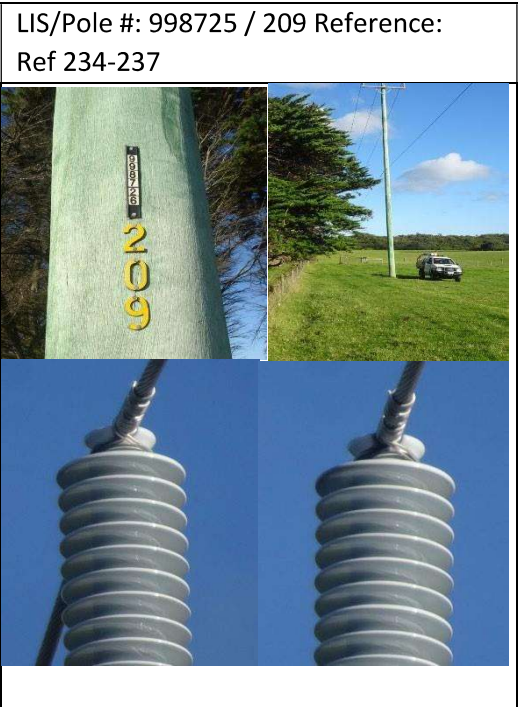
P3 corroded tie xarm1 east + pole insulator	Low

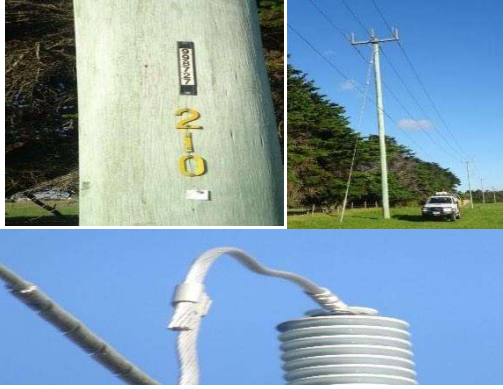
P3 corroded tie xarm1 west	Low

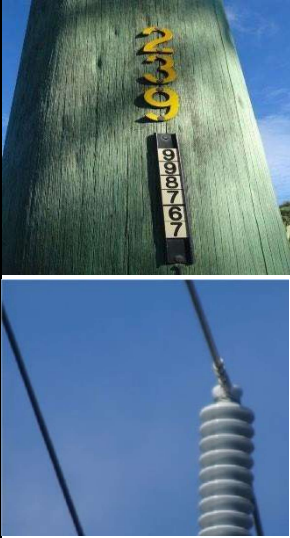
<p>P3 corroded tie xarm1 north</p>	<p>Low</p>
---	------------------------------------	------------

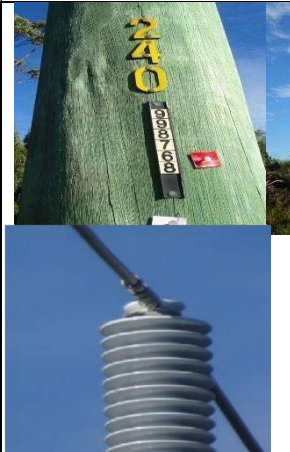
<p>P3 corroded tie xarm1 north</p>	<p>Low</p>

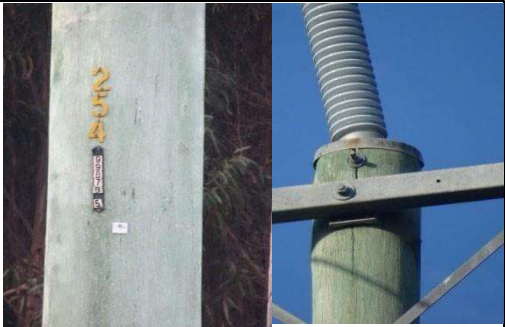
Split at top of pole due to incorrect installation - no defect just for records	N/A

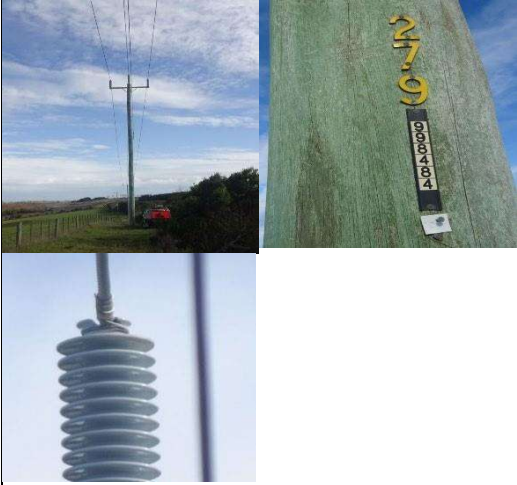
P3 corroded tie pole insulator	Low

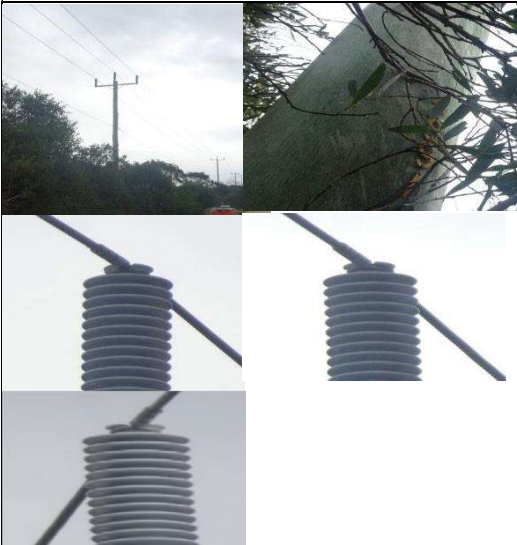
P3 corroded tie xarm1 north + south + pole insulator	Low

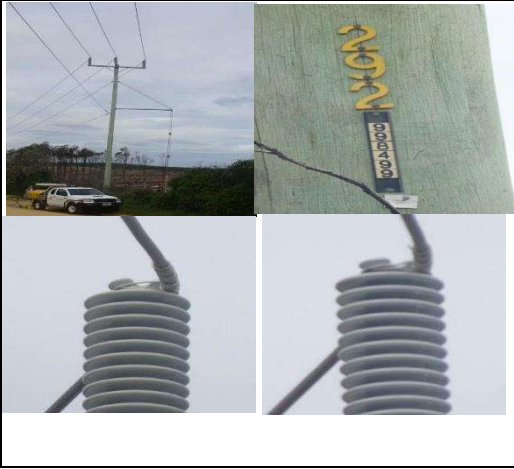
P3 corroded tie xarm1 south + pole	Low
<p>LIS/Pole #: 732286 / 292A Reference: Ref 291-293</p>	Observation	Priority

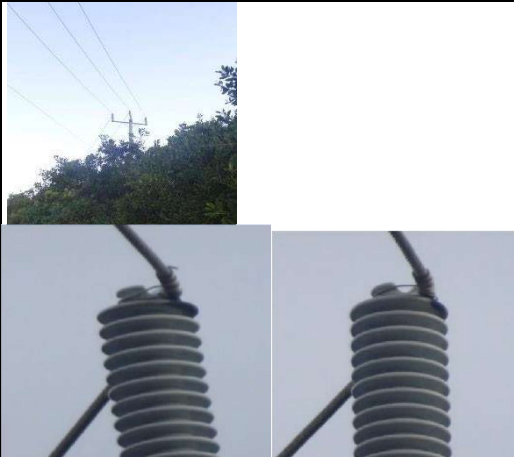
P3 corroded tie xarm1 north + pole insulator	Low

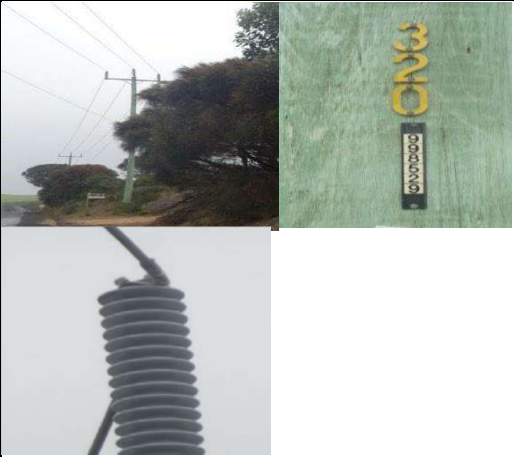
P3 corroded tie pole insulator	Low
LIS/Pole #: 998530 / 321 Reference: Ref 313-315	Observation	Priority

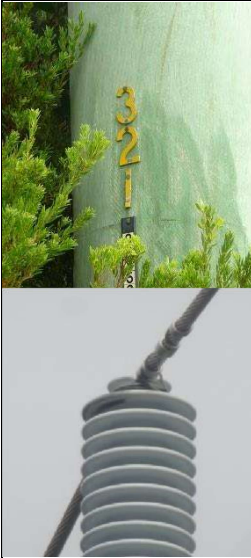
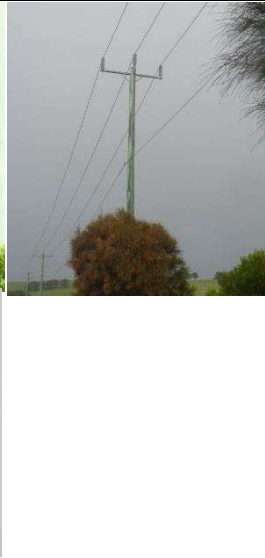
P3 corroded tie xarm1 east	N/A
LIS/Pole #: 998531 / 322 Reference: Ref 316-319	Observation	Priority

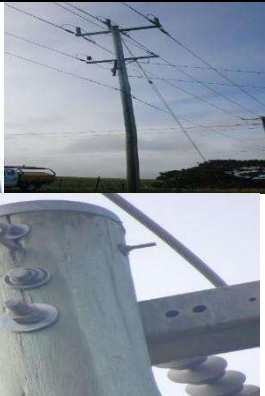
Split at top of pole due to incorrect installation - no defect just for records	N/A

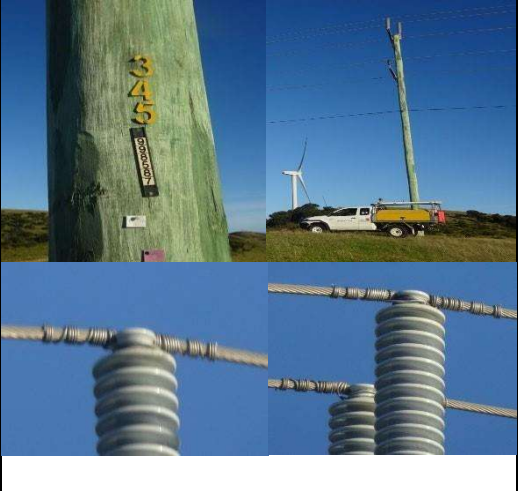
P3 corroded tie xarm1 west + east	Low
---	-----------------------------------	-----

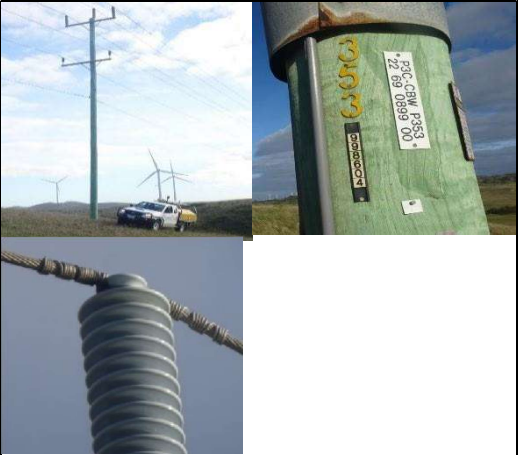
P3 corroded tie xarm1 west	Low

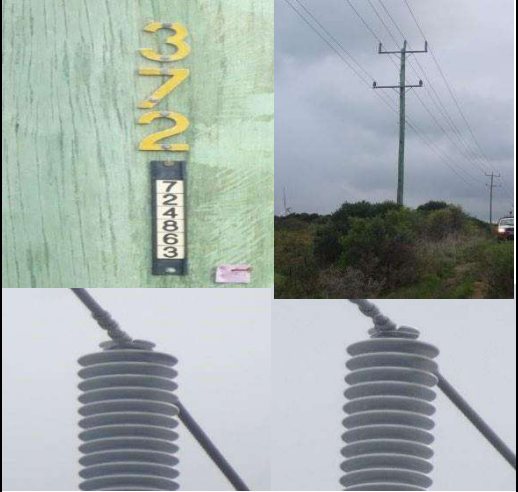
<p>P3 corroded tie xarm1 west + east</p>	<p>Low</p>
<p>LIS/Pole #: 724864 / 373 Reference: Ref 344-347</p>

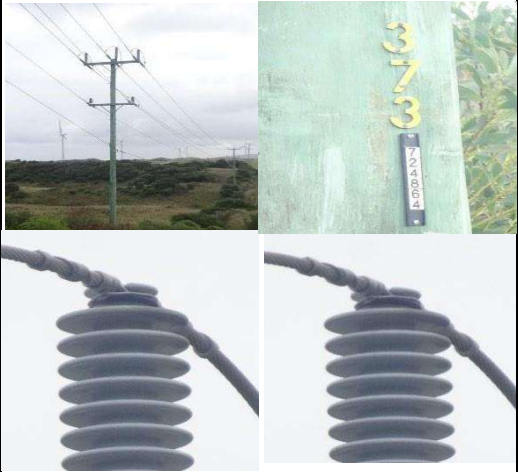
<p>Observation</p> <p>P3 corroded tie xarm1 east</p>	<p>Priority</p> <p>Low</p>

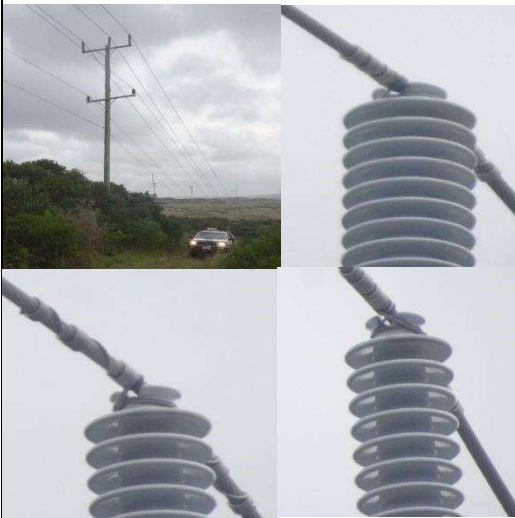
P3 corroded tie xarm1 west + east + pole	Low

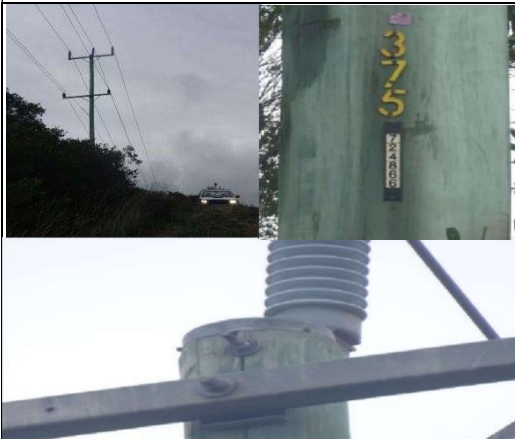
Split at top of pole due to incorrect installation - no defect just for records	N/A

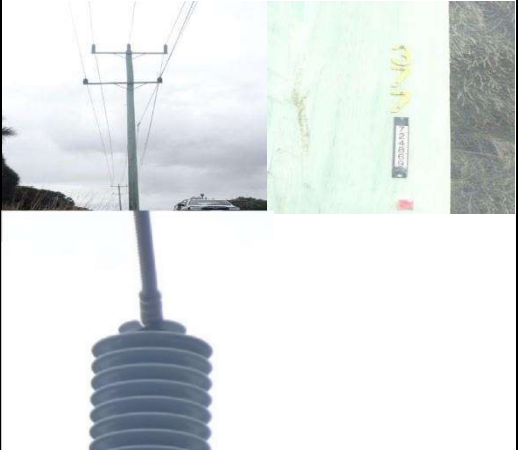
P3 corroded tie xarm1 west	Low
---	----------------------------	-----

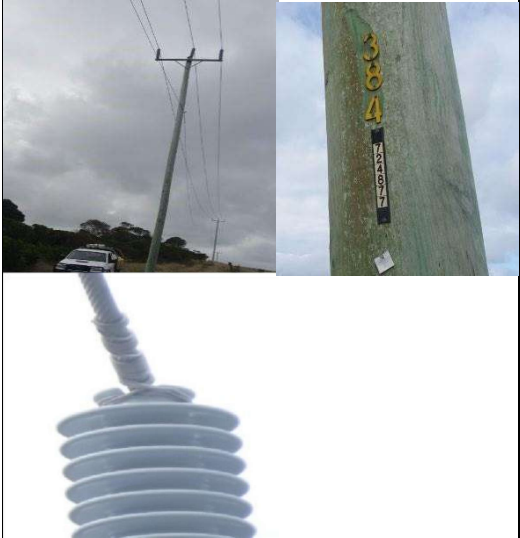
P3 corroded tie xarm1 south	Low
---	-----------------------------	-----

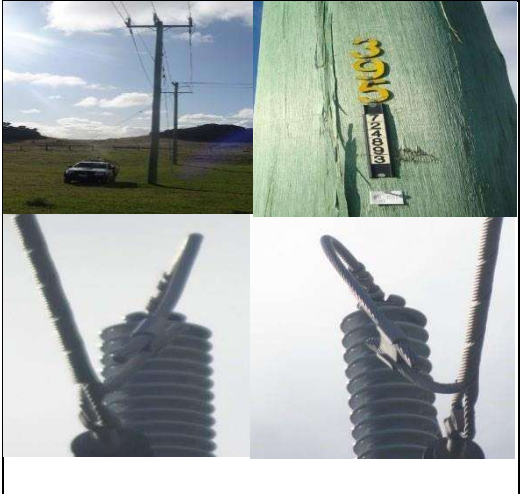
P3 corroded tie xarm1 X2	Low

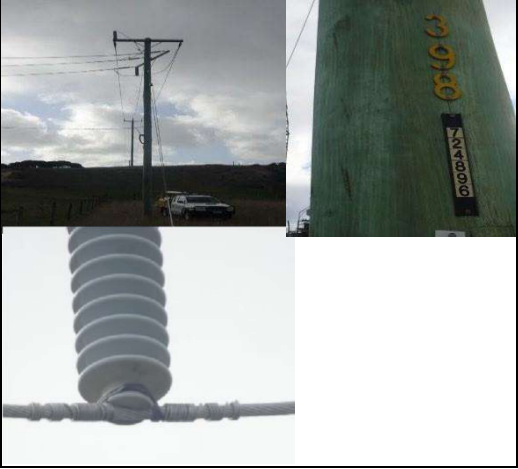
<p>P3 corroded tie xarm2</p>	<p>Low</p>
<p>LIS/Pole #: 745396 / 2 Reference: Ref 373-376</p>

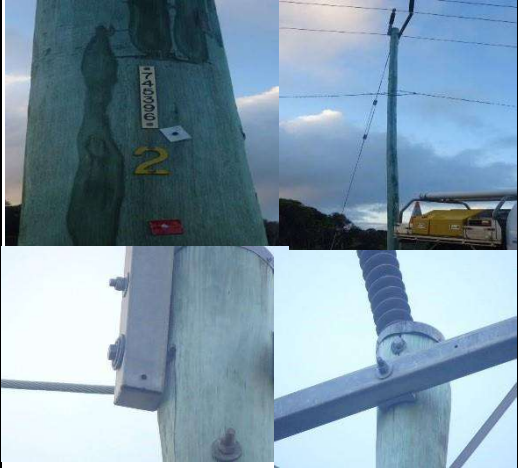
<p>Observation</p> <p>Split at top of pole due to incorrect installation - if it is to open up anymore pole will need to be replaced. I would suggest regular inspections</p>	<p>Priority</p>
<p>LIS/Pole #: 745403/ 9 Reference: Ref 377-380</p>

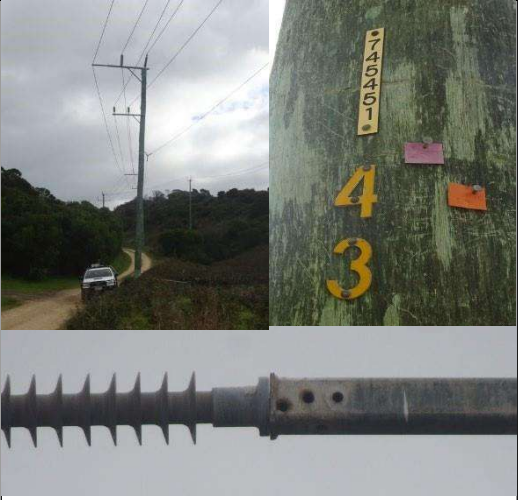
P2 loose insulator nut xarm1 south	Medium
<p>LIS/Pole #: 745455 / 47 Reference: Ref 390-393</p>	Observation	Priority

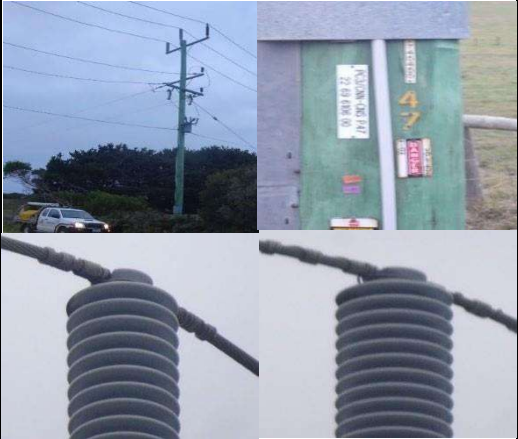
P3 corroded tie xarm1 east + pole	Low
<p>LIS/Pole #: 745486 / 64 Reference: Ref 394-397</p>	Observation	Priority

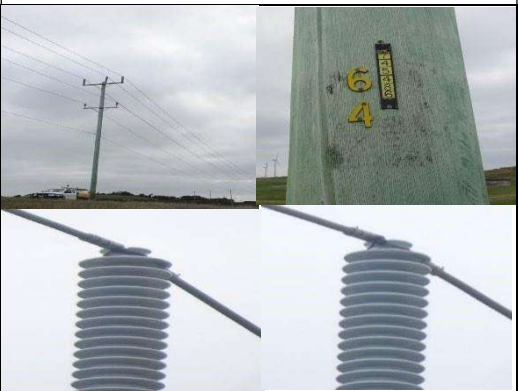
P3 corroded tie xarm1 north + south	Low

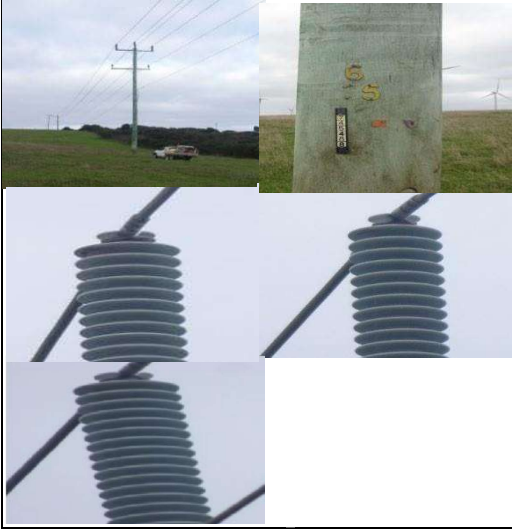
P3 corroded tie xarm1 north + south + pole	Low
LIS/Pole #: 784940 / 72 Reference: Ref 403-406	Observation	Priority
